Accelerated Load Testing to Compare the Performance of Full-Depth Reclamation with Foamed Asphalt Under Three Environmental Conditions

David Jones, Stefan Louw, and Rongzong Wu

Transportation Research Record: Journal of the Transportation Research Board, No. 2640, 2017, pp. 58–68.
<http://dx.doi.org/10.3141/2640-07>

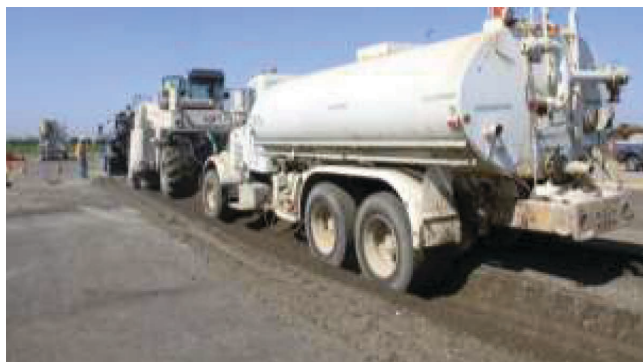
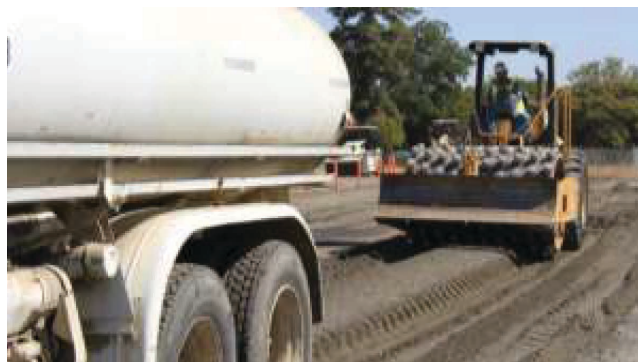
FIGURE 1 Test track construction: (a) pulverization and mixing and (b) water addition and compaction.

Conventional FDR construction procedures were followed. On the FDR-FA section, cement was first spread onto the pavement, after which the recycling train (binder tanker, recycler, and water tanker) made a single pass (Figure 1a). Some water was added to raise the

moisture content to a suitable level for compaction. Compaction and finishing followed the same process as that for the unstabilized section (Figure 1b). The test sections were allowed to cure for 10 days before the asphalt was placed. The FDR-FA section was kept moist during the curing period.

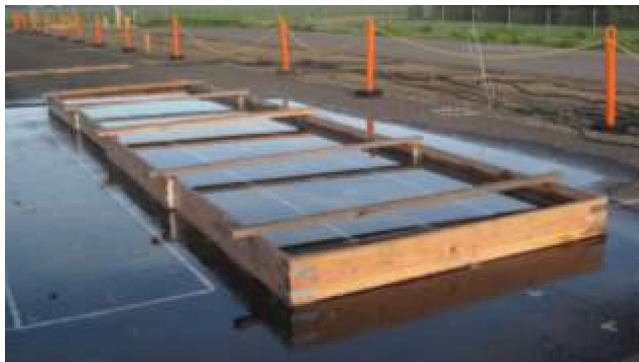
FIGURE 3 Presoak before HVS testing.

In the wet test, the test section was soaked with water for 10 days prior to HVS testing, to accelerate the onset of any potential moisture damage and represent typical conditions on roads in heavily irrigated agricultural areas. The soaking period was based on previous studies to determine optimal soaking times for soaked HVS testing (22). A row of holes was drilled in the bottom of the asphalt concrete layer on the side of each test section, to facilitate water ingress into the base. The holes were 25 mm in diameter, 250 mm from the edge of the HVS test section, and 250 mm apart. A wooden dam, 200 mm high and 300 mm from the edge of the test section, was then glued to the pavement with silicone, to provide a head of water (Figure 3). The dam was kept full of water for the duration of the soaking period. During HVS testing, a constant flow of water at approximately 1.5 L/h was maintained through irrigation tubes positioned in each hole in the asphalt layer, to ensure that the base remained in a soaked condition. Excess water was allowed to flow across the surface, thereby allowing infiltration through any cracks in the asphalt concrete. This water was maintained at a temperature of 30°C ±4°C to prevent cooling of the pavement surface. This testing condition was considered to be an extreme worst case to illustrate the importance of ensuring good drainage on rehabilitated roads, something that may be overlooked in some

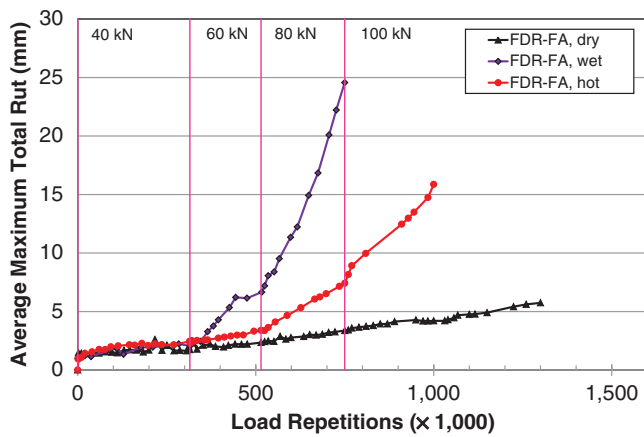
FIGURE 4 Surface permanent deformation.

Permanent surface deformation (average maximum rut being the measurement from the bottom of the rut to the top of the displaced material on the side of the wheelpath) measured on the three sections is shown in Figure 4.

Significantly more rutting was noted on the wet and high-temperature sections compared with the dry section, as expected, with the higher rate of rutting on the high-temperature section primarily attributed to the higher layer moisture contents rather than to the higher test temperature. Average maximum rut recorded on the dry section after 1.371 million load repetitions [equivalent to 34 million equivalent single-axle wheel loads (ESALs); see Table 1 for loads applied during the test] was about 5.0 mm, well below the terminal

average maximum rut of 13 mm. Terminal rutting was recorded on the wet and high-temperature sections after 625,000 and 910,000 wheel repetitions, respectively, which equates to 3.5 million and 12.8 million ESALs, respectively. The wet and high-temperature test sections were also load sensitive, with each load change resulting in an embedment phase and increased rut rate per load repetition. Performance on the dry section did not appear to be load sensitive.

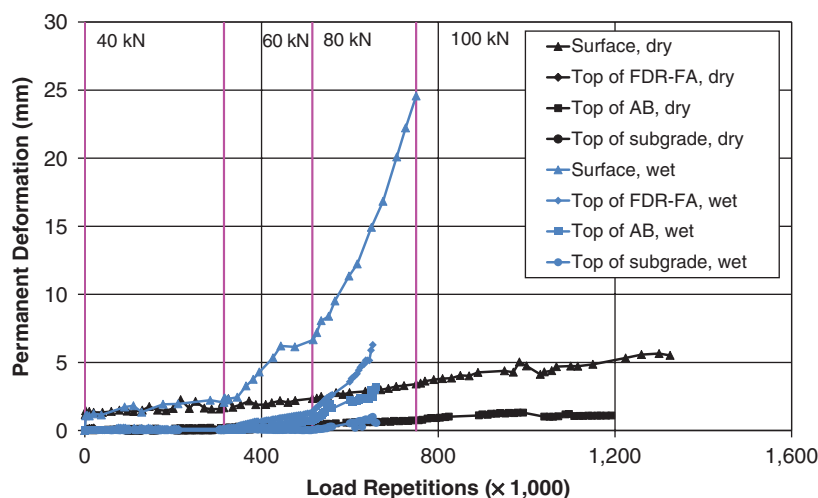
FIGURE 6 Permanent deformation in surface and underlying layers.

Permanent deformation in the underlying layers, recorded with MDDs, compared with the surface layer (recorded with a laser profilometer)

is shown in Figure 6 for the dry and wet tests. Although LVDTs were installed in the high-temperature test, they failed early (lost contact with the hole) due to higher than optimal moisture conditions caused by soaking on the adjacent wet tests. Some LVDT failures also occurred on the dry and wet tests under trafficking, and consequently a full set of data could not be collected. However, the MDD measurements that were collected were consistent with the laser profilometer measurements. On the dry test, the limited permanent deformation appeared to be primarily in the surfacing. On the wet test, the deformation appears to have been distributed between the surfacing, recycled layer, and existing aggregate base. Rutting in the subgrade was similar in both sections and very limited (about 1 mm). Given that limited data were collected from the MDDs, the extent of permanent deformation was carefully evaluated during the forensic investigation, which is discussed in the next section of the paper.

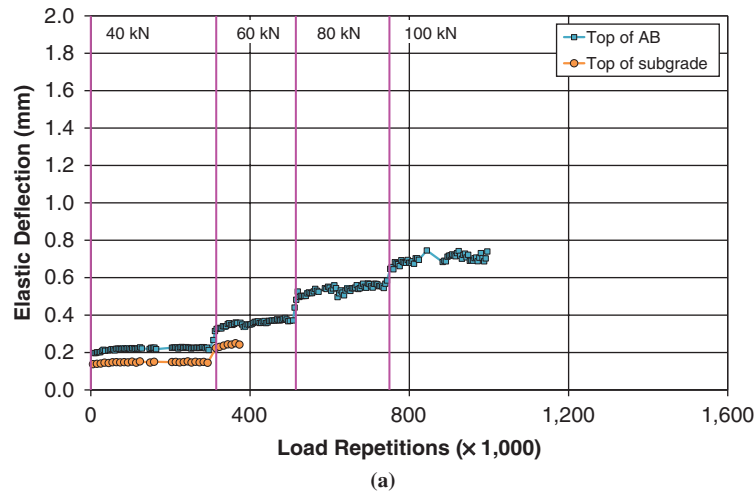
FIGURE 7 Elastic deflection in the underlying layers (MDD): (a) FDR-FA, dry; and (b) FDR-FA, wet.

Figure 7 shows the history of in-depth elastic deflections, measured by the LVDTs in the MDDs, for the dry and wet test sections. These readings are consistent with the surface deflections measured with the RSD shown in Figure 8.

On the dry test, there was a consistent increase in vertical deflections measured at the different depths after each load change, but no significant changes during testing at each load. These results suggest a general decrease in overall stiffness of the pavement structure over the duration of the test. Similar results were observed at the top of the existing aggregate base, and at the top of the subgrade on the wet test; however, deflections increased significantly at the top of the FDR layer, which was attributed to debonding between the asphalt concrete and the FDR layer.
