Full-Depth Recycling Study: Test Track Construction and First-Level Analysis of Phase 1 and Phase 2 HVS Testing, Forensic Investigation, and Phase 1 Laboratory Testing

Partnered Pavement Research Center (PPRC) Contract Strategic Plan Element 4.59 (DRISI Task 2707):
Guidelines for Full-Depth Reclamation of Pavements

DOCUMENT RETRIEVAL PAGE		Research Report: UCPRC-RR-2015-02			
Title: Full-Depth Recycling Study: Test Track Construction and First-Level Analysis of Phase 1 and Phase 2 HVS Testing, Forensic Investigation, and Phase 1 Laboratory Testing					
Authors: D. Jones, S. Louw, and R. Wu					
Caltrans Technical Lead: D. Maskey					
Prepared for: Caltrans	FHWA No.: CA172707A	Report Submitted: 04/21/2016		Final Publication Date 07/11/2016	
Strategic Plan Element No: 4.59	DRISI Task No.: 2707	Status: Final		Version No.: 1	
<p>Abstract:</p> <p>This first-level report describes the first two phases of a study comparing the performance of four different full-depth pavement reclamation strategies, namely pulverization with no stabilization (FDR-NS), stabilization with foamed asphalt and portland cement (FDR-FA), stabilization with portland cement only (FDR-PC), and stabilization with

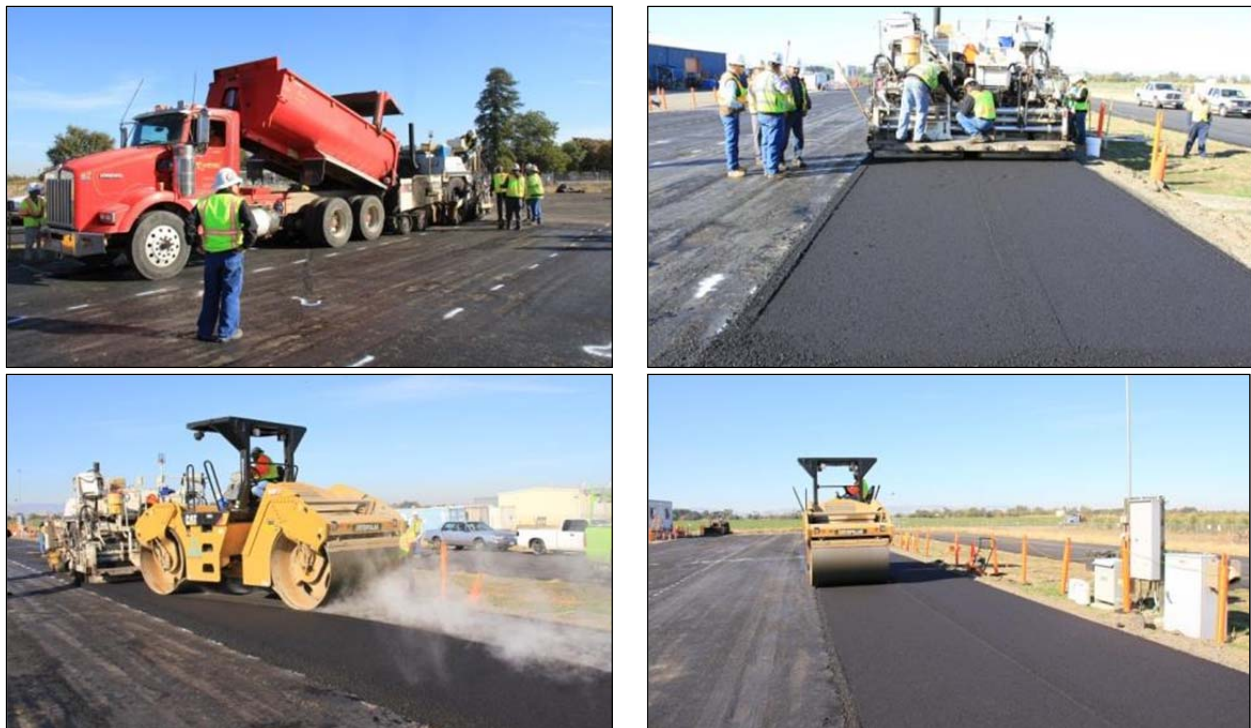
Figure 3.37: Asphalt concrete placement.

Mix was transported using end-dump trucks. Paving was carried out in a west-east direction and followed conventional procedures (Figure 3.37). Work started in Lane #1, followed by Lanes #2, #3, and #4. The second lift on Lane #1 (Cell #2) was placed after completion of the first lift on the other lanes. A breakdown roller closely followed the paver, applying about four passes. A single pass was made with an intermediate rubber-tired roller, followed by another four passes with a finish roller. Compaction of the lower lift appeared to be consistent and no problems were noted (Figure 3.38). On the second lift placed in Cell #2, the mix appeared tender and some shearing was noted (Figure 3.39) in the vicinity of the instrumentation cables (discussed in Section 4.4).

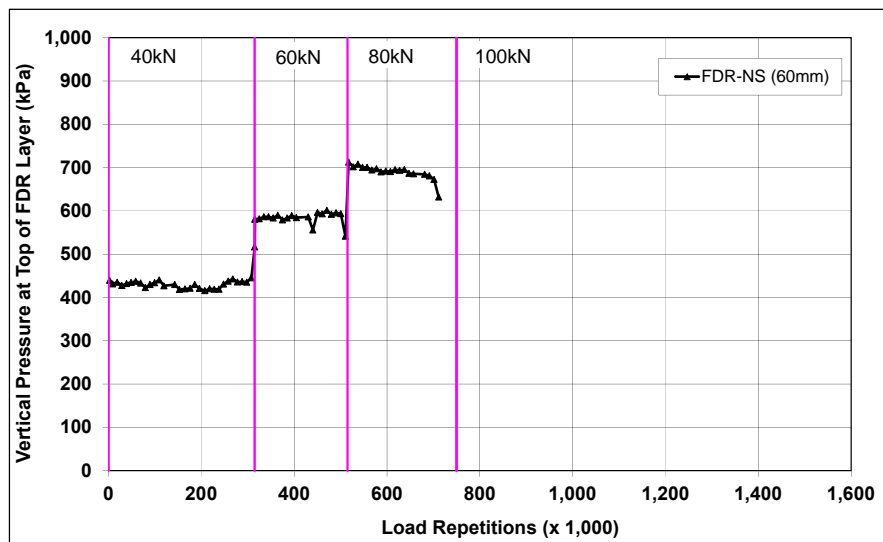
Figure 5.11: 672HB: Vertical pressure at the top of the recycled layer.

Figure 5.11 shows the traffic-induced vertical pressure at the top of the recycled base layer. Pressure readings were stable, but sensitive to load change, for the duration of the test. Increases in recorded pressures occurred after the load changes, as expected. The reason for the decrease in pressure at the end of the test is unclear, but it is assumed that either the instrumentation was damaged or support conditions under the pressure cell changed.
